EASTMAN PERFORMANCE FILMS, LLC. AIRBLAST LOADING TEST REPORT

ASTM F1642/GSA TS01 TESTING ON *LLUMAR SCL SR PS8* SAFETY AND SECURITY FILM INSTALLED ON A FIXED WINDOW SYSTEM (DUAL PANE, ANNEALED, SILICONE GLAZING ATTACHMENT)

REPORT NUMBER 14621.07-119-12 R0

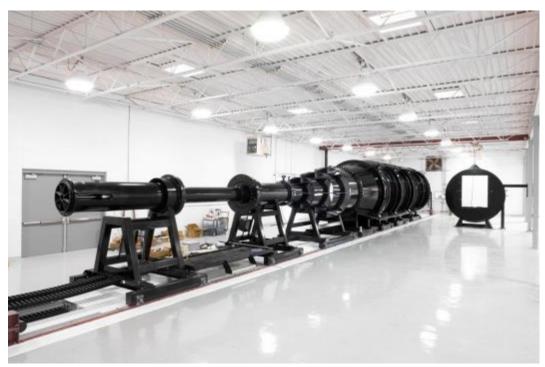
Figure #1 Shock Tube and Test Facility

Intertek B&C's shock tube is housed in a 10,000 square foot state-of-the-art test facility located in York, Pennsylvania. A photograph of the shock tube is provided in Figure #1.

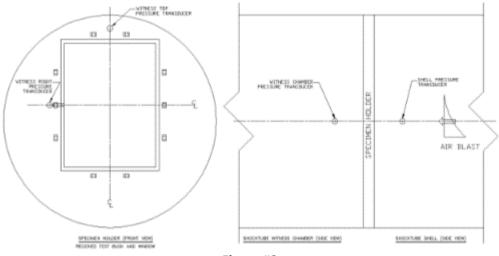
Figure #2 Pressure Sensor Locations

In accordance with ASTM F1642 and GSA TS01, four reflective pressure transducers were utilized for data acquisition at a 1MHz sample rate. Two reflective pressure transducers were located on the specimen holder at the top and right side (when viewed from the interior). A third pressure transducer was located on the shell to the exterior of the specimen, and a fourth was located in the witness chamber, directly to the interior of the specimen holder. A sketch of the specimen holder and corresponding reflective pressure sensor locations is provided in Figure #2.

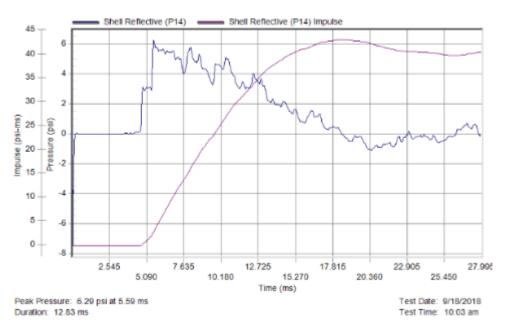
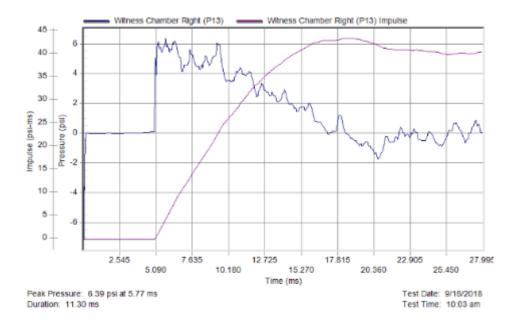
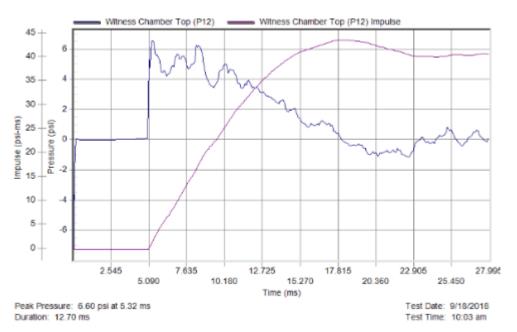
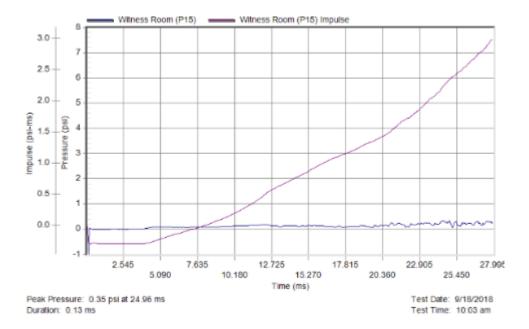
Test Specimen #1 - Pressure Time Plots

DESCRIPTION	RESULTS
Ambient Temperature	80°F
Glazing Temperature	81°F
ASTM Hazard Rating	No Hazard
GSA Performance Condition	2
PEAK POSITIVE PRESSURE	
Top Pressure	6.60 psi
Right Pressure	6.39 psi
Shell Pressure	6.29 psi
Average Pressure	6.43 psi
Witness Chamber Pressure	0.35 psi
PEAK POSITIVE PHASE DURATION	
Top Duration	12.70 msec
Right Duration	11.30 msec
Shell Duration	12.83 msec
Average Duration	12.28 msec
PEAK POSITIVE PHASE IMPULSE	
Top Impulse	43 psi*msec
Right Impulse	43 psi*msec
Shell Impulse	43 psi*msec
Average Impulse	43 psi*msec
GLAZING RESPONSE	
Exterior Lite	Fractured
Interior Lite	Fractured
Glazing Pullout Length and Location	None
Glazing Tearing	None
WITNESS CHAMBER RESULTS	
No debris was observed.

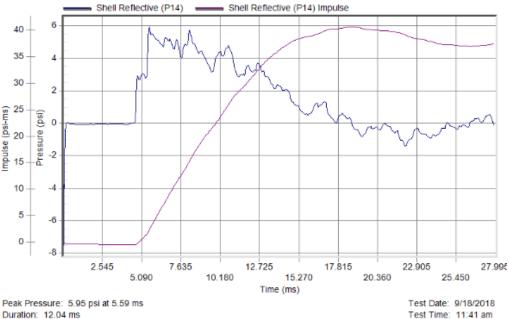
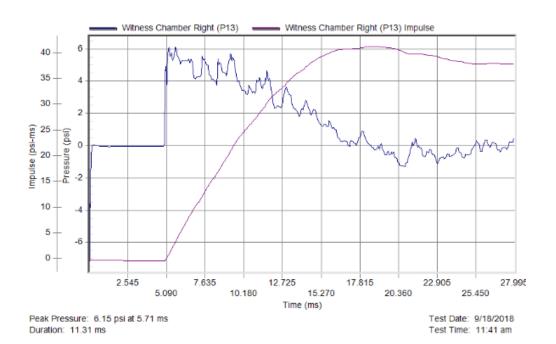
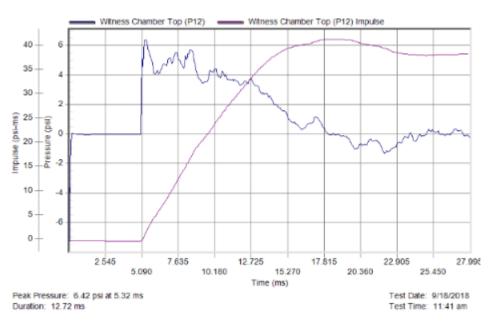
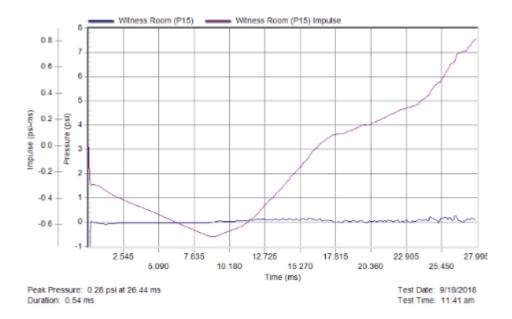
Test Specimen #2 - Pressure Time Plots

DESCRIPTION	RESULTS
Ambient Temperature	79°F
Glazing Temperature	79°F
ASTM Hazard Rating	No Hazard
GSA Performance Condition	2
PEAK POSITIVE PRESSURE	
Top Pressure	6.42 psi
Right Pressure	6.15 psi
Shell Pressure	5.95 psi
Average Pressure	6.17 psi
Witness Chamber Pressure	0.28 psi
PEAK POSITIVE PHASE DURATION	
Top Duration	12.72 msec
Right Duration	11.31 msec
Shell Duration	12.04 msec
Average Duration	12.02 msec
PEAK POSITIVE PHASE IMPULSE	
Top Impulse	41 psi*msec
Right Impulse	41 psi*msec
Shell Impulse	40 psi*msec
Average Impulse	41 psi*msec
GLAZING RESPONSE	
Exterior Lite	Fractured
Interior Lite	Fractured
Glazing Pullout Length and Location	None
Glazing Tearing	None
WITNESS CHAMBER RESULTS	
No debris was observed.

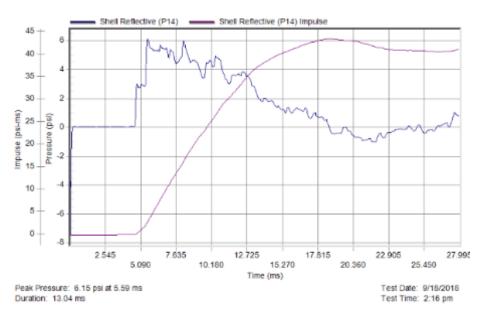
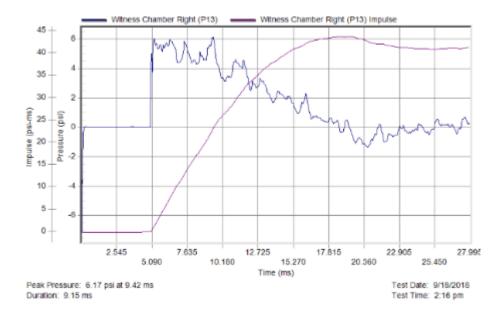
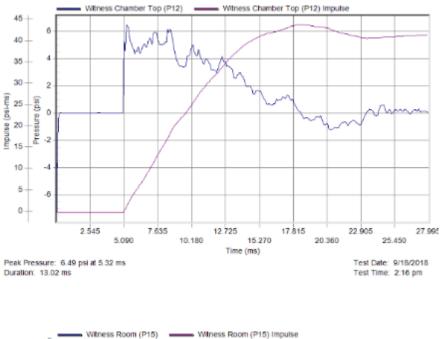
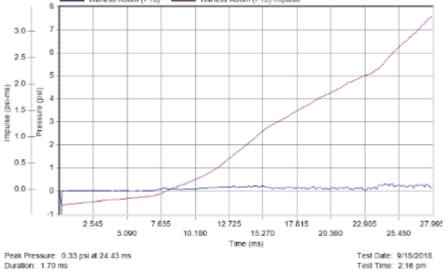
Test Specimen #3 - Pressure Time Plots

DESCRIPTION	RESULTS
Ambient Temperature	81°F
Glazing Temperature	71°F
ASTM Hazard Rating	No Hazard
GSA Performance Condition	2
PEAK POSITIVE PRESSURE	
Top Pressure	6.49 psi
Right Pressure	6.17 psi
Shell Pressure	6.15 psi
Average Pressure	6.27 psi
Witness Chamber Pressure	0.33 psi
PEAK POSITIVE PHASE DURATION	
Top Duration	13.02 msec
Right Duration	9.15 msec
Shell Duration	13.04 msec
Average Duration	11.74 msec
PEAK POSITIVE PHASE IMPULSE	
Top Impulse	44 psi*msec
Right Impulse	44 psi*msec
Shell Impulse	43 psi*msec
Average Impulse	44 psi*msec
GLAZING RESPONSE	
Exterior Lite	Fractured
Interior Lite	Fractured
Glazing Pullout Length and Location	None
Glazing Tearing	None
WITNESS CHAMBER RESULTS	
No debris was observed.

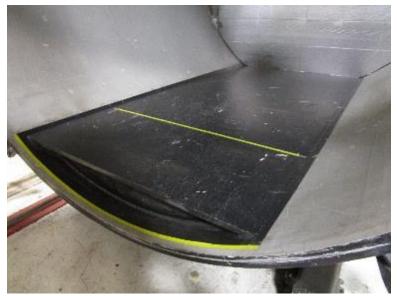
Photo No. 3 Post-test Specimen #1, Witness Chamber

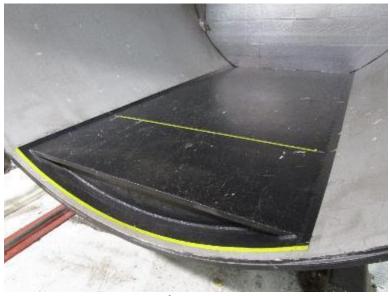
Photo No. 6 Post-test Specimen #2, Witness Chamber

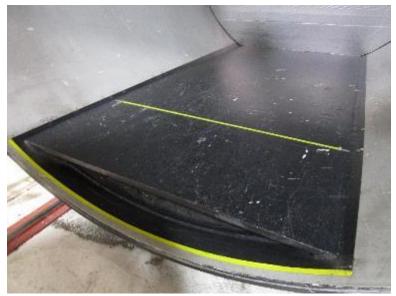
Photo No. 9 Post-test Specimen #3, Witness Chamber

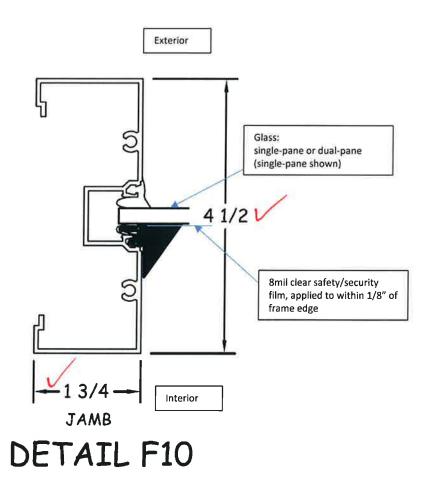
Eastman Performance Films, LLC Intertek Quote 199023R4 Shock Tube Test Sample Details

Dual-pane unit frames

Kawneer 451 Aluminum Framing

<u>Single-pane unit frames</u> Kawneer 450 Aluminum Framing

The test specimen drawings which follow have been reviewed by Intertek B&C and are representative of the test specimen(s) reported herein. Test specimen construction was verified by Intertek B&C per the drawings included in this report. Any deviations are documented herein or on the drawings.
