EASTMAN PERFORMANCE FILMS, LLC AIRBLAST LOADING TEST REPORT

ASTM F1642/GSA TS01 TESTING ON *R20 SR PS9* SAFETY AND SECURITY PERFORMANCE FILM INSTALLED ON A FIXED WINDOW SYSTEM (DUAL PANE, ANNEALED, SILICONE GLAZING ATTACHMENT)

J3983.10-119-12 RO

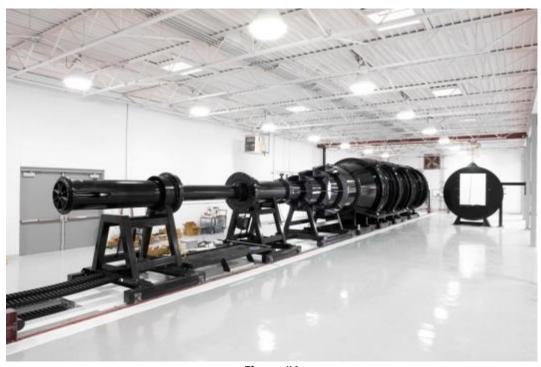
Figure #1
Shock Tube and Test Facility

Intertek B&C's shock tube is housed in a 10,000 square foot state-of-the-art test facility located in York, Pennsylvania. A photograph of the shock tube is provided in Figure #1.

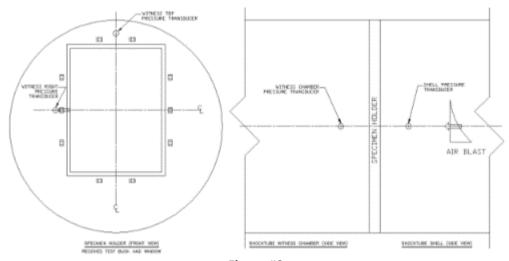
Figure #2
Pressure Sensor Locations

In accordance with ASTM F1642 and GSA TS01, four reflective pressure transducers were utilized for data acquisition at a 1MHz sample rate. Two reflective pressure transducers were located on the specimen holder at the top and right side (when viewed from the interior). A third pressure transducer was located on the shell to the exterior of the specimen, and a fourth was located in the witness chamber, directly to the interior of the specimen holder. A sketch of the specimen holder and corresponding reflective pressure sensor locations is provided in Figure #2.

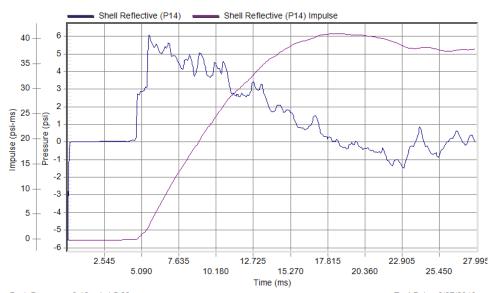
Test Specimen #1 - Pressure Time Plots

Peak Pressure:
 6.16 psi at 5.62 ms
 Test Date:
 6/27/2019

Duration:
 12.48 ms
 Test Time:
 7:57 am

Test Specimen #1			
DESCRIPTION	RESULTS		
Ambient Temperature	86°F		
Glazing Temperature	87°F		
ASTM Hazard Rating	No Hazard		
GSA Performance Condition	2		
PEAK POSITIVE PRESSURE			
Top Pressure	6.22 psi		
Right Pressure	6.32 psi		
Shell Pressure	6.16 psi		
Average Pressure	6.23 psi		
Witness Chamber Pressure	0.27 psi		
PEAK POSITIVE PHASE DURATION			
Top Duration	12.38 msec		
Right Duration	11.16 msec		
Shell Duration	12.48 msec		
Average Duration	12.01 msec		
PEAK POSITIVE PHASE IMPULSE			
Top Impulse	41 psi*msec		
Right Impulse	41 psi*msec		
Shell Impulse	41 psi*msec		
Average Impulse	41 psi*msec		
GLAZING RESPONSE			
Exterior Lite	Fractured		
Interior Lite	Unbroken		
Glazing Pullout	None		
Film Tearing	None		
WITNESS CHAMBER RESULTS			
A dusting of glass was deposited on the witness chamber floor.

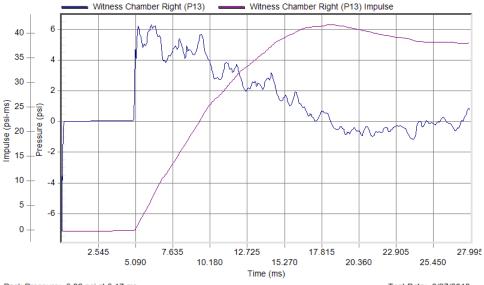
Peak Pressure: 6.32 psi at 6.17 ms
 Test Date: 6/27/2019

Duration: 11.16 ms
 Test Time: 7:57 am

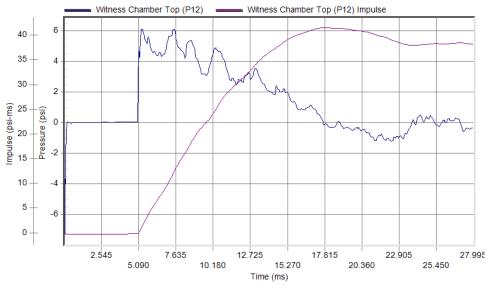
Test Specimen #1 - Pressure Time Plots (continued)

Peak Pressure:
 6.22 psi at 5.32 ms
 Test Date: 6/27/2019

Duration:
 12.38 ms
 Test Time: 7:57 am

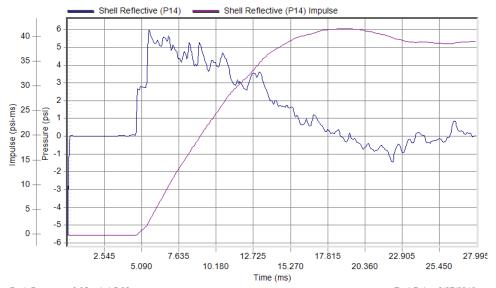
Test Specimen #2 - Pressure Time Plots

Peak Pressure:
 6.05 psi at 5.62 ms
 Test Date:
 6/27/2019

Duration:
 13.06 ms
 Test Time:
 9:18 am

rest Specimen #2			
DESCRIPTION	RESULTS		
Ambient Temperature	85°F		
Glazing Temperature	86°F		
ASTM Hazard Rating	No Hazard		
GSA Performance Condition	2		
PEAK POSITIVE PRESSURE			
Top Pressure	6.48 psi		
Right Pressure	6.42 psi		
Shell Pressure	6.05 psi		
Average Pressure	6.32 psi		
Witness Chamber Pressure	0.28 psi		
PEAK POSITIVE PHASE DURATION			
Top Duration	10.41 msec		
Right Duration	12.02 msec		
Shell Duration	13.06 msec		
Average Duration	11.83 msec		
PEAK POSITIVE PHASE IMPULSE			
Top Impulse	42 psi*msec		
Right Impulse	42 psi*msec		
Shell Impulse	42 psi*msec		
Average Impulse	42 psi*msec		
GLAZING RESPONSE			
Exterior Lite	Fractured		
Interior Lite	Unbroken		
Glazing Pullout	None		
Film Tearing	None		
WITNESS CHAMBER RESULTS			
A dusting of glass was deposited on the witnes	s chamber floor.

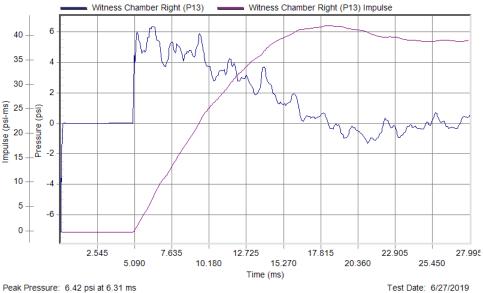
Peak Pressure: 6.42 psi at 6.31 ms
 Test Date: 6/27/2015

Duration: 12.02 ms
 Test Time: 9:18 am

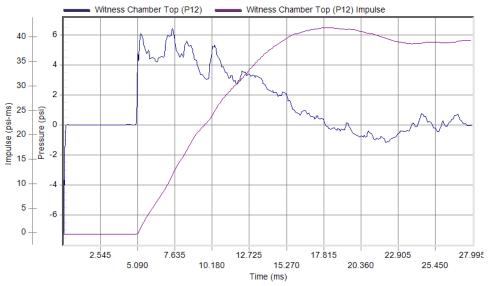
Test Specimen #2 - Pressure Time Plots (continued)

Peak Pressure:
 6.48 psi at 7.49 ms
 Test Date: 6/27/2019

Duration:
 10.41 ms
 Test Time: 9:18 am

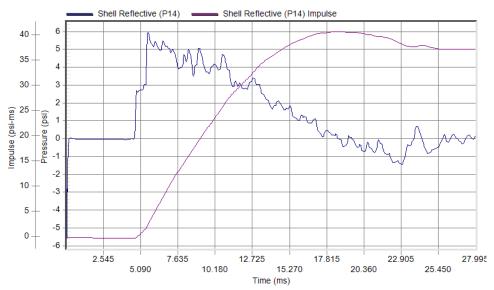
Test Specimen #3 - Pressure Time Plots

Peak Pressure: 5.99 psi at 5.61 ms
 Test Date: 6/27/2019

Duration: 12.94 ms
 Test Time: 10:19 am

Test Specimen #3	
DESCRIPTION	RESULTS
Ambient Temperature	86°F
Glazing Temperature	87°F
ASTM Hazard Rating	No Hazard
GSA Performance Condition	2
PEAK POSITIVE PRESSURE	
Top Pressure	6.20 psi
Right Pressure	6.22 psi
Shell Pressure	5.99 psi
Average Pressure	6.14 psi
Witness Chamber Pressure	0.23 psi
PEAK POSITIVE PHASE DURATION	
Top Duration	12.80 msec
Right Duration	12.00 msec
Shell Duration	12.94 msec
Average Duration	12.58 msec
PEAK POSITIVE PHASE IMPULSE	
Top Impulse	41 psi*msec
Right Impulse	41 psi*msec
Shell Impulse	41 psi*msec
Average Impulse	41 psi*msec
GLAZING RESPONSE	
Exterior Lite	Fractured
Interior Lite	Unbroken
Glazing Pullout	None
Film Tearing	None
WITNESS CHAMBER RESULTS	
A dusting of glass was deposited on the with	ness chamber floor.

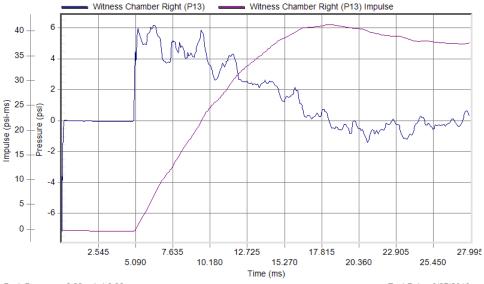
Peak Pressure: 6.22 psi at 6.32 ms
 Test Date: 6/27/2019

Duration: 12.00 ms
 Test Time: 10:19 am

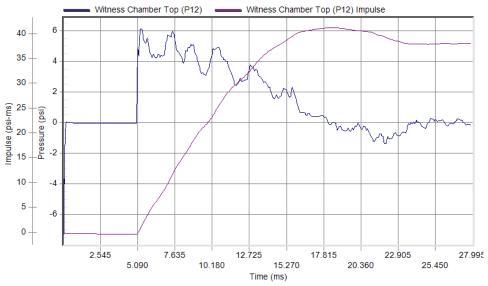
Test Specimen #3 - Pressure Time Plots (continued)

Peak Pressure: 6.20 psi at 5.32 ms Test Date: 6/27/2019 Duration: 12.80 ms Test Time: 10:19 am

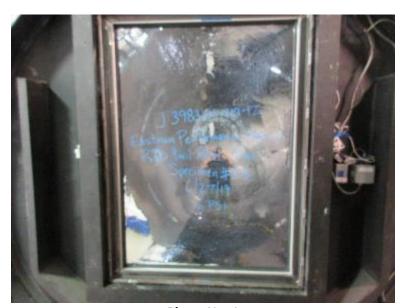
Photo No. 1
Post-test Specimen #1, Interior

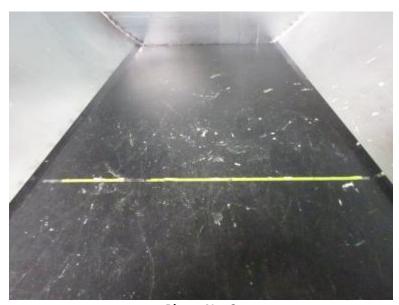
Photo No. 2
Post-test Specimen #1, Witness Chamber

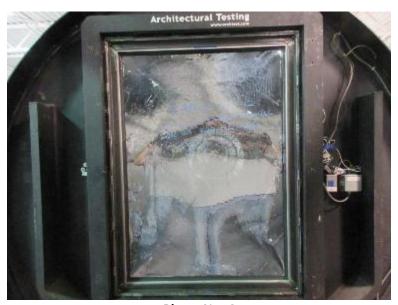
Photo No. 4
Post-test Specimen #2, Interior

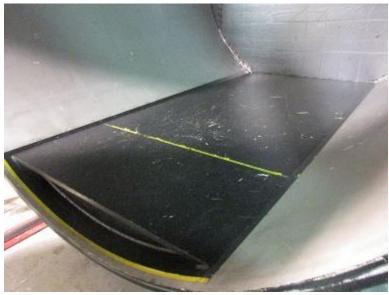
Photo No. 5
Post-test Specimen #2, Witness Chamber

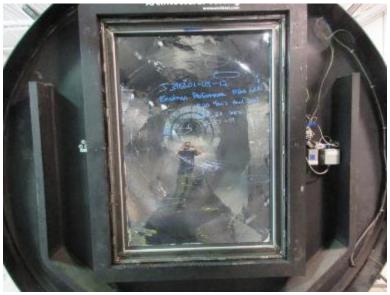
Photo No. 7
Post-test Specimen #3, Interior

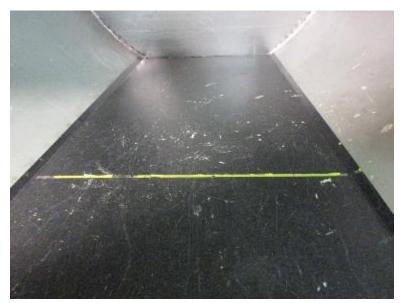
Photo No. 8
Post-test Specimen #3, Witness Chamber

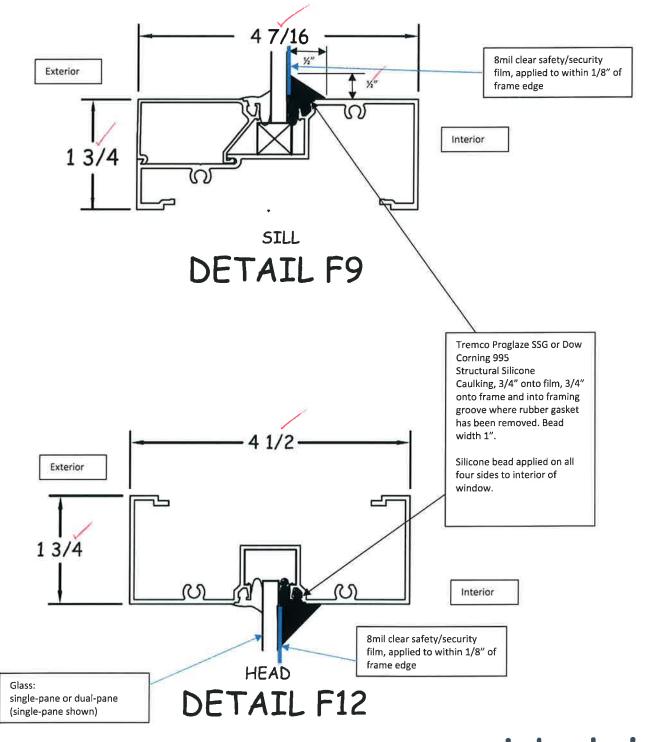
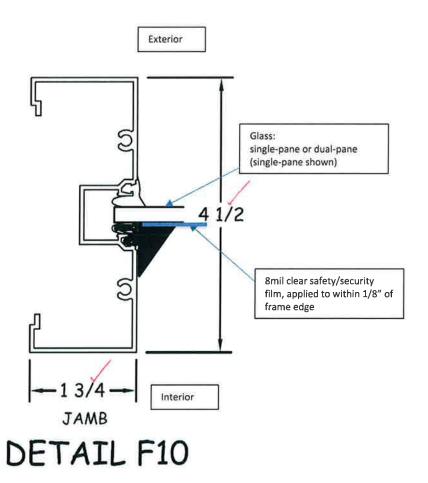
Eastman Performance Films, LLC Intertek Quote 210169R3 Shock Tube Test Sample Details

The test specimen drawings which follow have been reviewed by Intertek B&C and are representative of the test specimen(s) reported herein. Test specimen construction was verified by Intertek B&C per the drawings included in this report. Any deviations are documented herein or on the drawings.

Dual-pane unit frames

Kawneer 451 Aluminum Framing
