EASTMAN PERFORMANCE FILMS, LLC AIRBLAST LOADING TEST REPORT

ASTM F1642/GSA TS01 TESTING ON *R20 SR PS9* SAFETY AND SECURITY PERFORMANCE FILM INSTALLED ON A FIXED WINDOW SYSTEM (SINGLE PANE, TEMPERED, SILICONE GLAZING ATTACHMENT)

J3983.04-119-12 RO

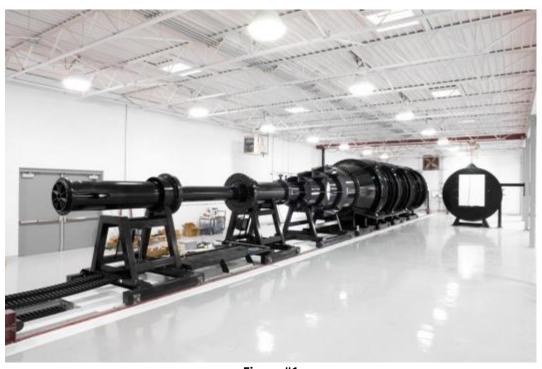
Intertek B&C's shock tube is housed in a 10,000 square foot state-of-the-art test facility located in York, Pennsylvania. A photograph of the shock tube is provided in Figure #1.

Figure #1
Shock Tube and Test Facility

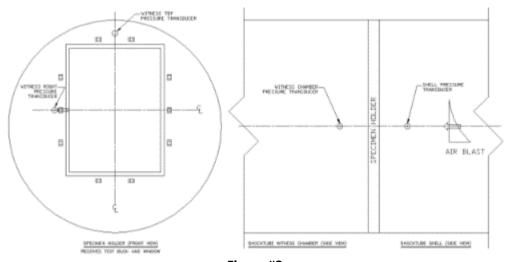
In accordance with ASTM F1642 and GSA TS01, four reflective pressure transducers were utilized for data acquisition at a 1MHz sample rate. Two reflective pressure transducers were located on the specimen holder at the top and right side (when viewed from the interior). A third pressure transducer was located on the shell to the exterior of the specimen, and a fourth was located in the witness chamber, directly to the interior of the specimen holder. A sketch of the specimen holder and corresponding reflective pressure sensor locations is provided in Figure #2.

Figure #2
Pressure Sensor Locations

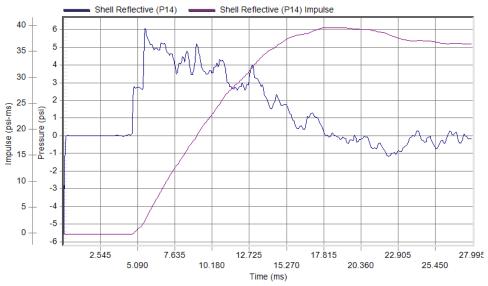
Peak Pressure:
 6.12 psi at 5.62 ms
 Test Date:
 6/19/2019

Duration:
 12.29 ms
 Test Time:
 4:05 pm

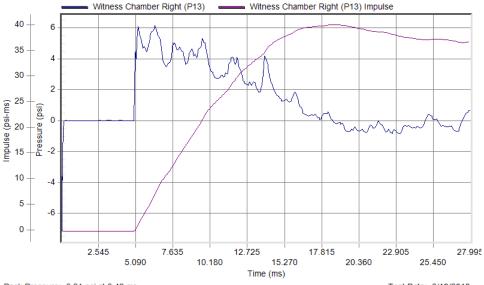
Peak Pressure: 6.21 psi at 6.42 ms
 Test Date: 6/19/2019

Duration: 11.26 ms
 Test Time: 4:05 pm

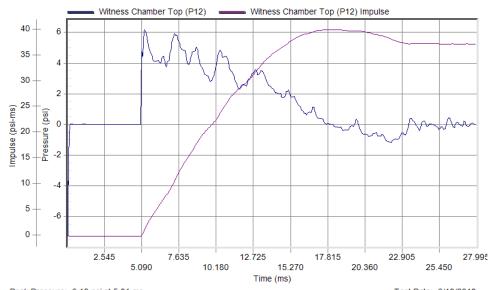
Peak Pressure:
 6.18 psi at 5.31 ms
 Test Date:
 6/19/2019

Duration:
 12.34 ms
 Test Time:
 4:05 pm

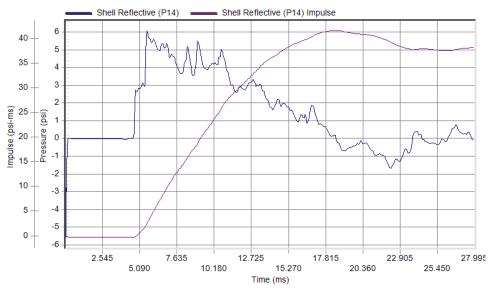
Peak Pressure:
 6.09 psi at 5.61 ms
 Test Date:
 6/20/2019

Duration:
 12.90 ms
 Test Time:
 10:24 am

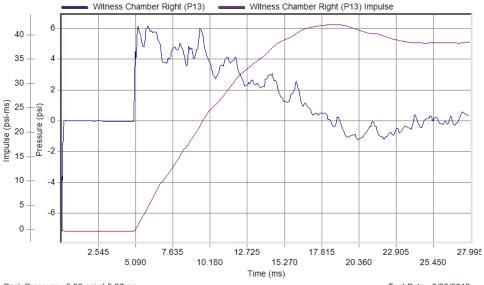
Peak Pressure: 6.23 psi at 5.97 ms
 Test Date: 6/20/2019

Duration: 12.30 ms
 Test Time: 10:24 am

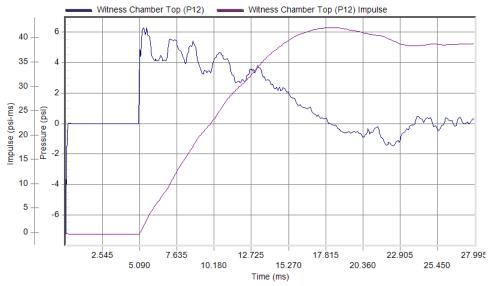
Peak Pressure:
 6.31 psi at 5.58 ms
 Test Date:
 6/20/2019

Duration:
 12.41 ms
 Test Time:
 10:24 am

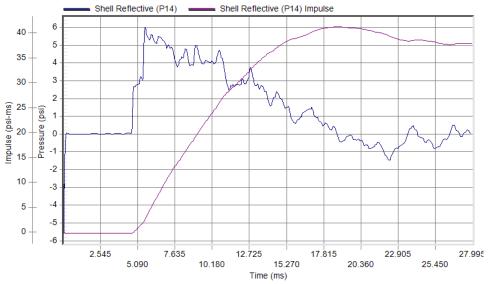
Peak Pressure:
 6.04 psi at 5.62 ms
 Test Date:
 6/20/2019

Duration:
 13.10 ms
 Test Time:
 11:53 am

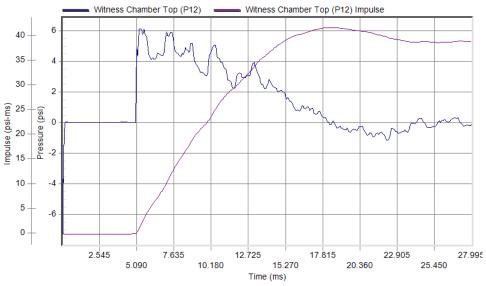
Peak Pressure:
 6.21 psi at 5.32 ms
 Test Date: 6/20/2019

Duration:
 12.86 ms
 Test Time: 11:53 am

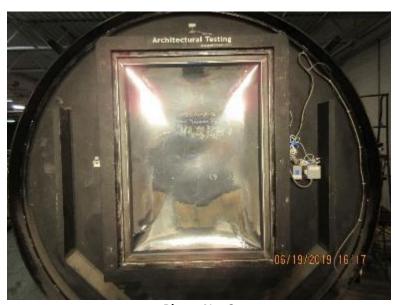
Photo No. 2
Post-test Specimen #1, Interior

rest Specimen #1		
DESCRIPTION	RESULTS	
Ambient Temperature	85°F	
Glazing Temperature	87°F	
ASTM Hazard Rating	No Hazard	
GSA Performance Condition	2	
PEAK POSITIVE PRESSURE		
Top Pressure	6.18 psi	
Right Pressure	6.21 psi	
Shell Pressure	6.12 psi	
Average Pressure	6.17 psi	
Witness Chamber Pressure	0.22 psi	
PEAK POSITIVE PHASE DURATION		
Top Duration	12.34 msec	
Right Duration	11.26 msec	
Shell Duration	12.29 msec	
Average Duration	11.97 msec	
PEAK POSITIVE PHASE IMPULSE		
Top Impulse	40 psi*msec	
Right Impulse	40 psi*msec	
Shell Impulse	40 psi*msec	
Average Impulse	40 psi*msec	
GLAZING RESPONSE		
Exterior Lite	Fractured	
Interior Lite	N/A	
Glazing Pullout	None	
Film Tearing	None	
WITNESS CHAMBER RESULTS		
Glazing cracked but remained fully retained. No	o damage observed to the witness panel.

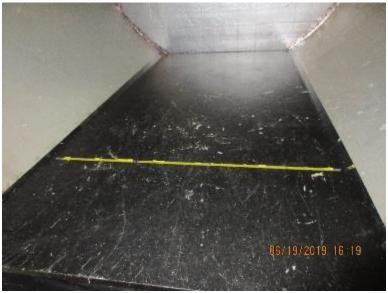
Photo No. 3
Post-test Specimen #1, Witness Chamber

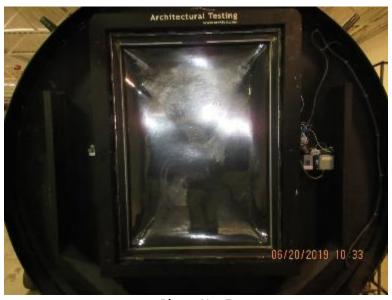
Photo No. 5
Post-test Specimen #2, Interior

l est Specimen #2	
DESCRIPTION	RESULTS
Ambient Temperature	82°F
Glazing Temperature	83°F
ASTM Hazard Rating	No Hazard
GSA Performance Condition	2
PEAK POSITIVE PRESSURE	
Top Pressure	6.31 psi
Right Pressure	6.23 psi
Shell Pressure	6.09 psi
Average Pressure	6.21 psi
Witness Chamber Pressure	0.28 psi
PEAK POSITIVE PHASE DURATION	
Top Duration	12.41 msec
Right Duration	12.30 msec
Shell Duration	12.90 msec
Average Duration	12.54 msec
PEAK POSITIVE PHASE IMPULSE	
Top Impulse	42 psi*msec
Right Impulse	42 psi*msec
Shell Impulse	42 psi*msec
Average Impulse	42 psi*msec
GLAZING RESPONSE	
Exterior Lite	Fractured
Interior Lite	N/A
Glazing Pullout	None
Film Tearing	None
WITNESS CHAMBER RESULTS

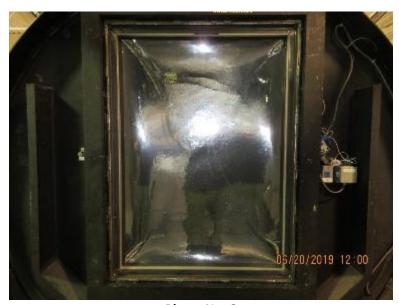
Photo No. 8
Post-test Specimen #3, Interior

rest Specimen #3	
DESCRIPTION	RESULTS
Ambient Temperature	83°F
Glazing Temperature	85°F
ASTM Hazard Rating	No Hazard
GSA Performance Condition	2
PEAK POSITIVE PRESSURE	
Top Pressure	6.21 psi
Right Pressure	6.48 psi
Shell Pressure	6.04 psi
Average Pressure	6.24 psi
Witness Chamber Pressure	0.27 psi
PEAK POSITIVE PHASE DURATION	
Top Duration	12.86 msec
Right Duration	9.04 msec
Shell Duration	13.10 msec
Average Duration	11.67 msec
PEAK POSITIVE PHASE IMPULSE	
Top Impulse	41 psi*msec
Right Impulse	41 psi*msec
Shell Impulse	41 psi*msec
Average Impulse	41 psi*msec
GLAZING RESPONSE	
Exterior Lite	Fractured
Interior Lite	N/A
Glazing Pullout	None
Film Tearing	None
WITNESS CHAMBER RESULTS	
Glazing cracked but remained fully retain	ned. No damage observed to the witness panel.

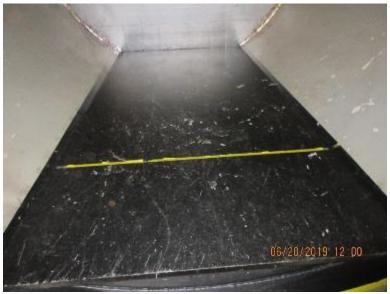
Photo No. 9
Post-test Specimen #3, Witness Chamber
