EASTMAN PERFORMANCE FILMS, LLC TEST REPORT

ASTM E1886 AND ASTM E1996 TESTING ON DR15 SR PS9 FILM, FIXED WINDOW

J3550.01-109-44

TEST REPORT FOR EASTMAN PERFORMANCE FILMS, LLC

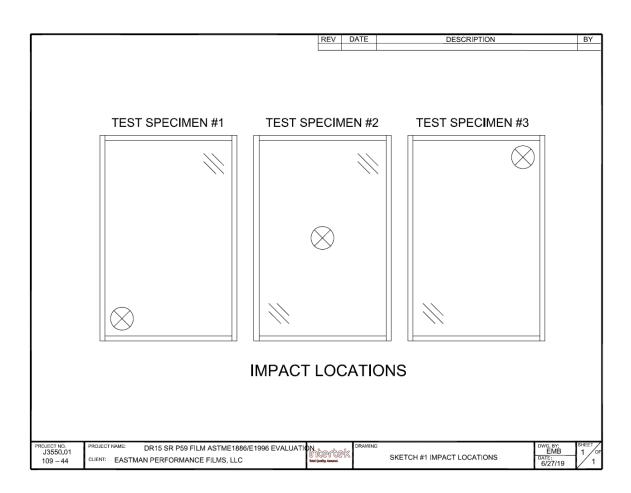
SKETCH #1
IMPACT LOCATIONS

IMPACT	#1		
MISSILE VELOCITY	12.1 m/s (39.8 fps)		
IMPACT AREA	Lower left corner of daylight opening		
OBSERVATIONS	Missile hit target area, broke sacrificial and interior lites, no further		
damage observed			
RESULTS	Pass

IMPACT	#1		
MISSILE VELOCITY	12.3 m/s (40.3 fps)		
IMPACT AREA	Center of daylight opening		
OBSERVATIONS	Missile hit target area, fractured sacrificial and interior lites, no missile		
penetration			
RESULTS	Pass

IMPACT	#1		
MISSILE VELOCITY	12.3 m/s (40.3 fps)		
IMPACT AREA	Top right corner of daylight opening		
OBSERVATIONS	Missile hit target area, missile fractured sacrificial and interior lites, tore laminate 2" long in L-Shape at impact location, no further damage		
RESULTS	Pass

Note: See Intertek B&C Sketch #1 for impact locations.

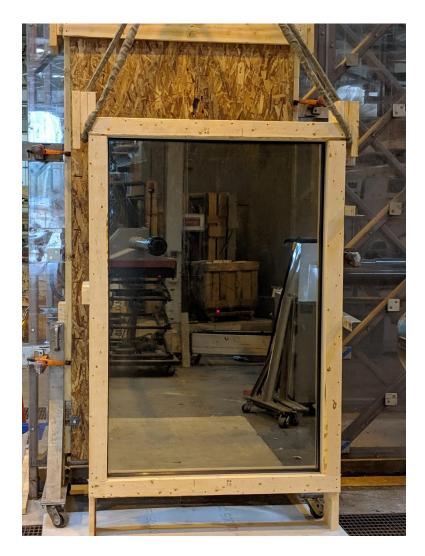
Photo No. 1 Test Specimen #2 Prior to Testing

Product Type: Fixed window **Series/Model**: DR15 SR PS9

OVERALL AREA:	WIDTH		HEIGHT	
2.2 m ² (24.0 ft ²)	millimeters inches i		millimeters	inches
Overall size	1219	48	1829	72

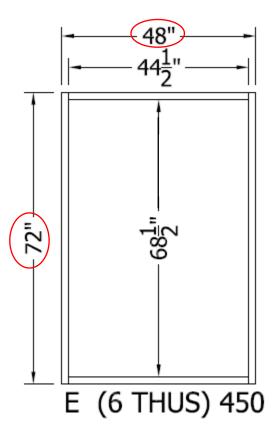
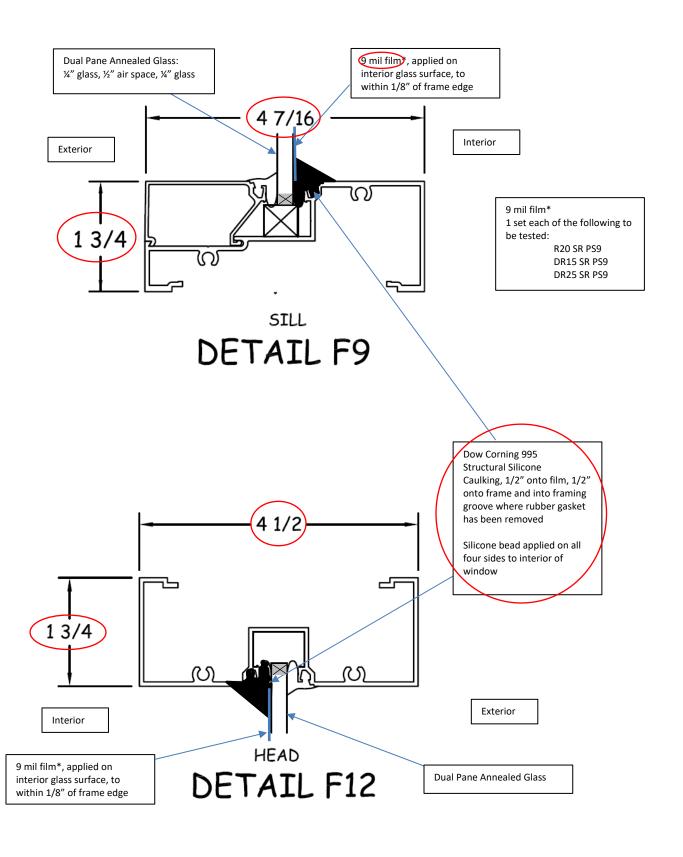
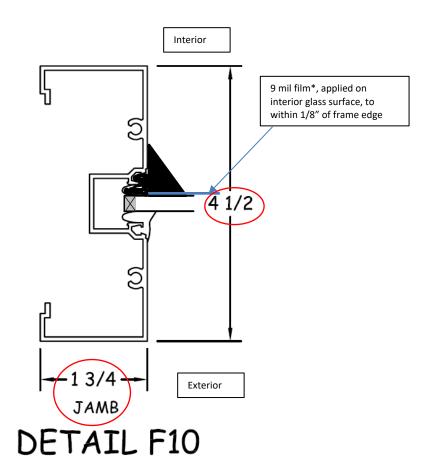
Eastman Performance Films, LLC Intertek Quote 210800R0 Windstorm Testing Test Sample Details

FRAME MEMBER	MATERIAL	DESCRIPTION
Head, sill, and jambs	Aluminum	Extruded, thermally improved, poured and debridged
	JOINERY TYPE	DETAIL
All corners	Butted	The corners were secured together using two #12 x 1" pan head screws through the head and sill and into the jamb screw bosses. Silicone was used to seal the gap at the glazing pocket.

GLASS TYPE	SPACER TYPE	INTERIOR LITE	EXTERIOR LITE	GLAZING METHOD
1" IG	Desiccant- filled aluminum spacer	1/4" clear annealed glass with a 0.009" laminate layer on the interior	1/4" clear annealed glass	Exterior glazed against a bead of Dow Corning 995 structural silicone and secured in place using a snap-in aluminum glazing bead at the sill with a rubber glazing strip against the glazing. A rubber glazing wedge was used at the exterior of the head, sill, and jambs.

Kawneer 450 Aluminum Framing

The test specimen drawings have been reviewed by Intertek B&C and are representative of the test specimen(s) reported herein. Test specimen construction was verified by Intertek B&C per the drawings included in this report. Any deviations are documented herein or on the drawings.
