EASTMAN PERFORMANCE FILMS, LLC

AIRBLAST LOADING TEST REPORT

ASTM F1642/GSA TS01 TESTING ON R20 SR PS9 SAFETY AND SECURITY PERFORMANCE FILM
INSTALLED ON A FIXED WINDOW SYSTEM
(DUAL PANE, TEMPERED, SILICONE GLAZING ATTACHMENT)

J3983.12-119-12 R0

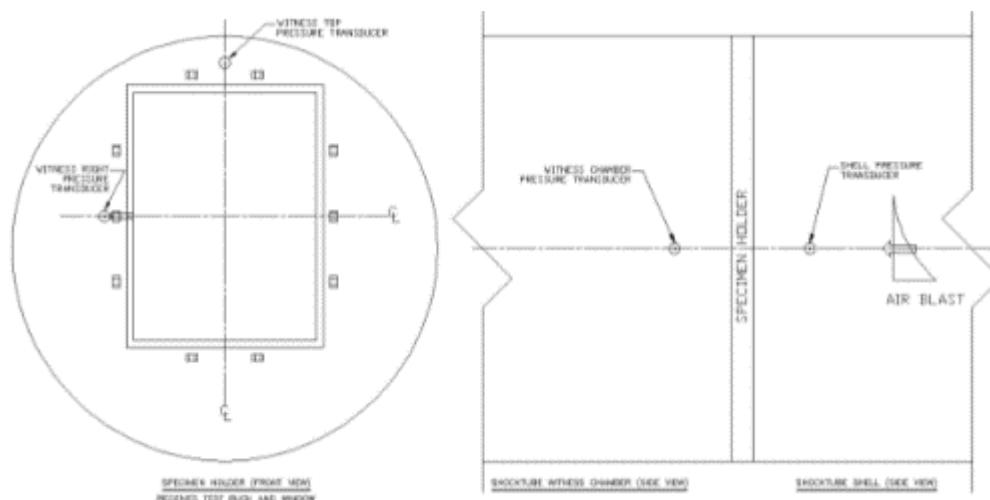
Figure #2
Pressure Sensor Locations

In accordance with ASTM F1642 and GSA TS01, four reflective pressure transducers were utilized for data acquisition at a 1MHz sample rate. Two reflective pressure transducers were located on the specimen holder at the top and right side (when viewed from the interior). A third pressure transducer was located on the shell to the exterior of the specimen, and a fourth was located in the witness chamber, directly to the interior of the specimen holder. A sketch of the specimen holder and corresponding reflective pressure sensor locations is provided in Figure #2.

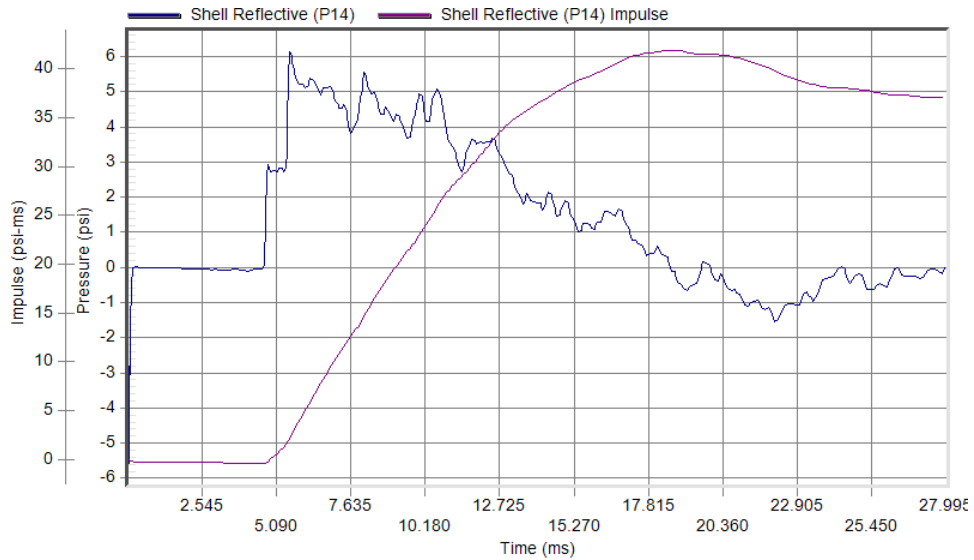
Peak Pressure: 6.18 psi at 5.57 ms
Duration: 12.97 ms

DESCRIPTION	RESULTS
Ambient Temperature	90°F
Glazing Temperature	92°F
ASTM Hazard Rating	No Hazard
GSA Performance Condition	2
PEAK POSITIVE PRESSURE	
Top Pressure	6.74 psi
Right Pressure	6.03 psi
Shell Pressure	6.18 psi
Average Pressure	6.31 psi
Witness Chamber Pressure	0.19 psi
PEAK POSITIVE PHASE DURATION	
Top Duration	12.73 msec
Right Duration	13.41 msec
Shell Duration	12.97 msec
Average Duration	13.03 msec
PEAK POSITIVE PHASE IMPULSE	
Top Impulse	42 psi*msec
Right Impulse	43 psi*msec
Shell Impulse	42 psi*msec
Average Impulse	42 psi*msec
GLAZING RESPONSE	
Exterior Lite	Fractured
Interior Lite	Unbroken
Glazing Pullout	None
Film Tearing	None
WITNESS CHAMBER RESULTS	
No debris was observed.

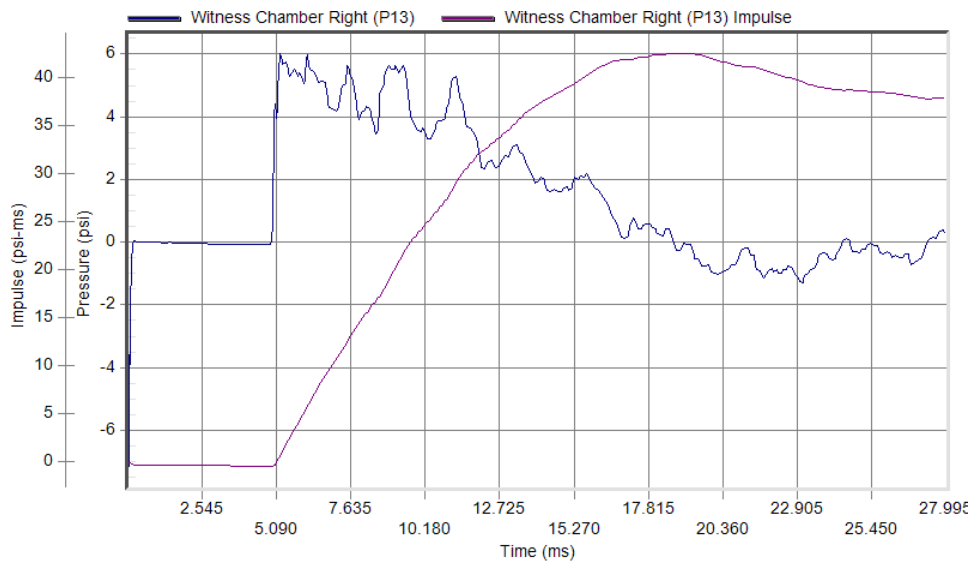
Peak Pressure: 6.03 psi at 5.25 ms
Duration: 13.41 ms

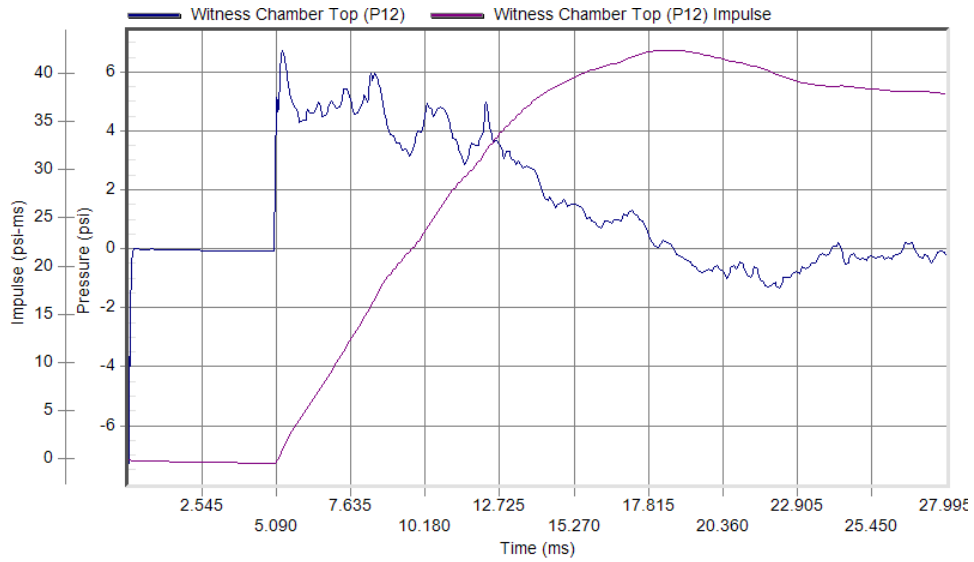
Peak Pressure: 6.74 psi at 5.31 ms
Duration: 12.73 ms

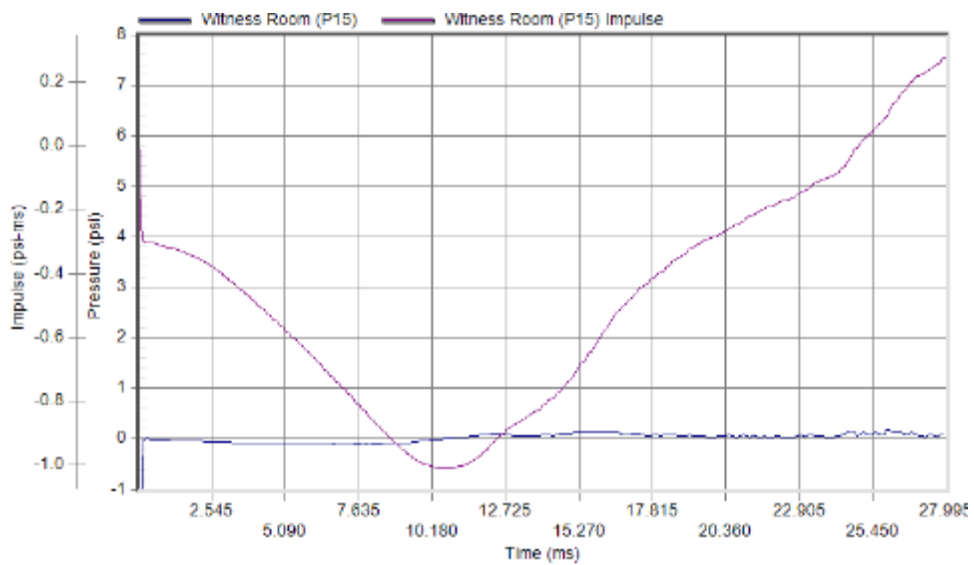
Peak Pressure: 0.19 psi at 25.98 ms
Duration: 1.13 ms

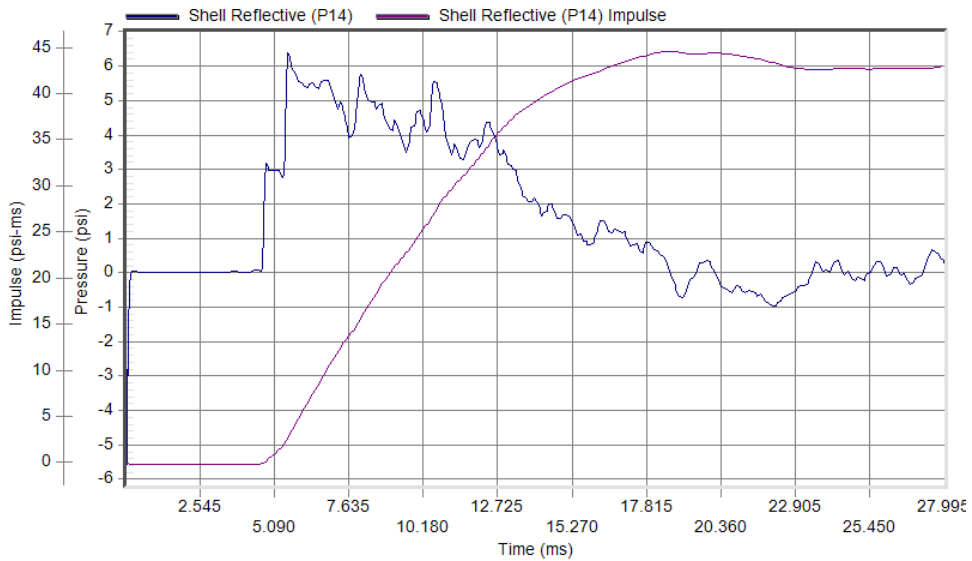
Peak Pressure: 6.43 psi at 5.59 ms
Duration: 12.99 ms

DESCRIPTION	RESULTS
Ambient Temperature	87°F
Glazing Temperature	89°F
ASTM Hazard Rating	No Break
GSA Performance Condition	1
PEAK POSITIVE PRESSURE	
Top Pressure	7.03 psi
Right Pressure	6.40 psi
Shell Pressure	6.43 psi
Average Pressure	6.62 psi
Witness Chamber Pressure	0.24 psi
PEAK POSITIVE PHASE DURATION	
Top Duration	12.94 msec
Right Duration	13.25 msec
Shell Duration	12.99 msec
Average Duration	13.06 msec
PEAK POSITIVE PHASE IMPULSE	
Top Impulse	45 psi*msec
Right Impulse	45 psi*msec
Shell Impulse	45 5si*msec
Average Impulse	45 psi*msec
GLAZING RESPONSE	
Exterior Lite	Unbroken
Interior Lite	Unbroken
Glazing Pullout	None
Film Tearing	None
WITNESS CHAMBER RESULTS	
No debris was observed.

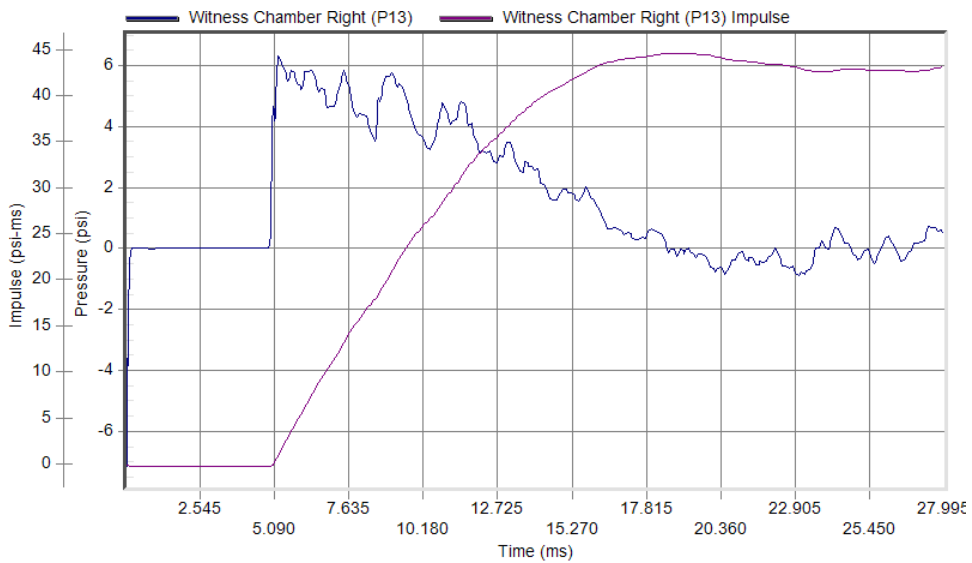
Peak Pressure: 6.40 psi at 5.26 ms
Duration: 13.25 ms

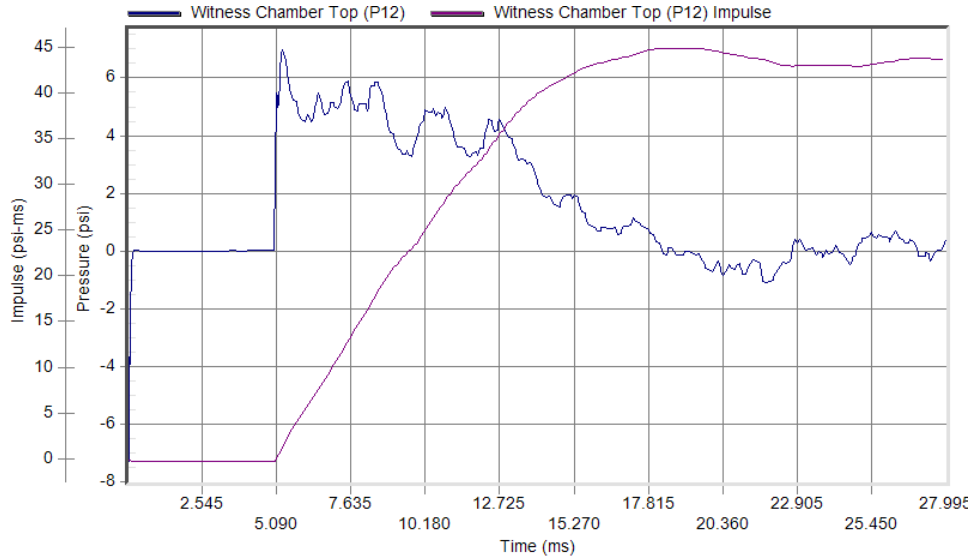
Peak Pressure: 7.03 psi at 5.32 ms
Duration: 12.94 ms

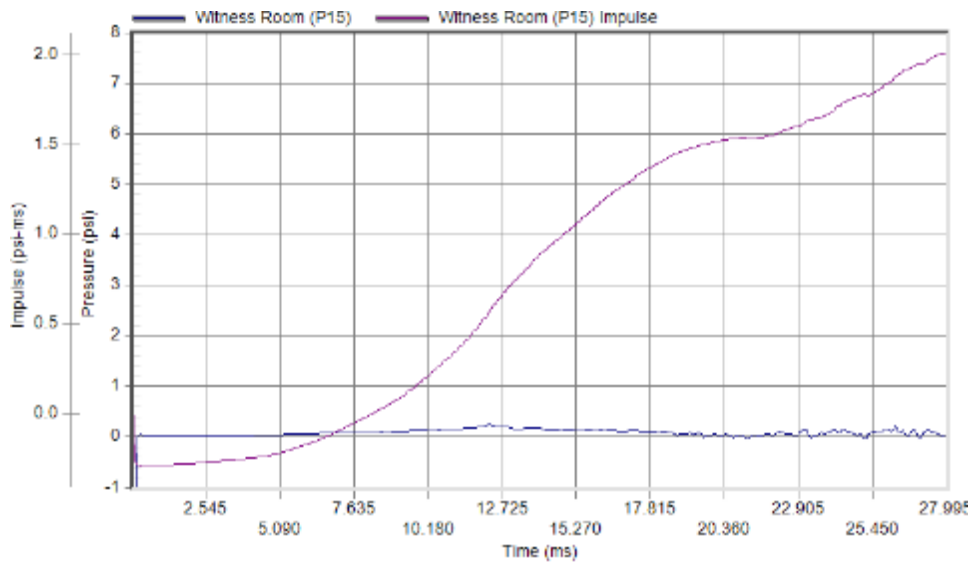
Peak Pressure: 0.24 psi at 12.25 ms
Duration: 7.39 ms

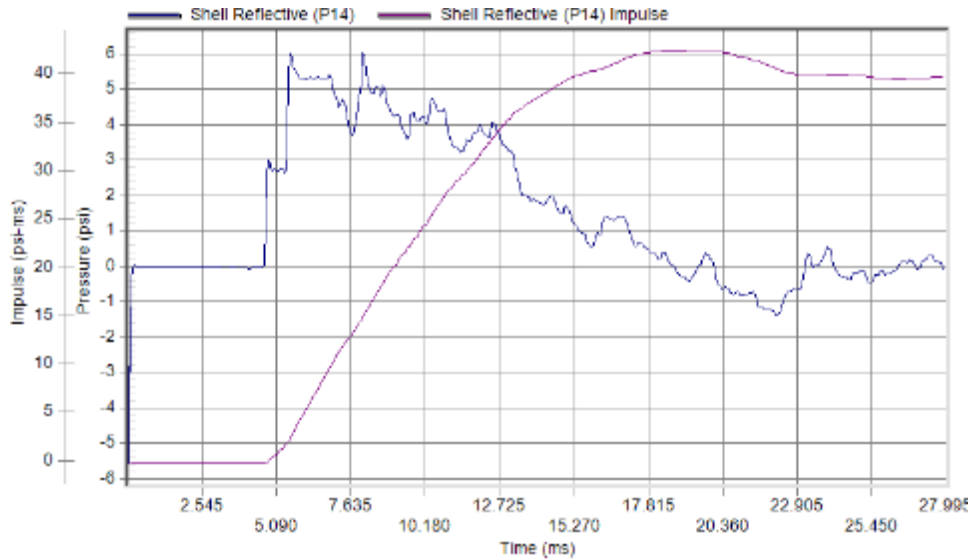
Peak Pressure: 6.11 psi at 8.08 ms
Duration: 10.50 ms

DESCRIPTION	RESULTS
Ambient Temperature	89°F
Glazing Temperature	90°F
ASTM Hazard Rating	No Break
GSA Performance Condition	1
PEAK POSITIVE PRESSURE	
Top Pressure	6.74 psi
Right Pressure	6.15 psi
Shell Pressure	6.11 psi
Average Pressure	6.33 psi
Witness Chamber Pressure	0.13 psi
PEAK POSITIVE PHASE DURATION	
Top Duration	12.91 msec
Right Duration	13.35 msec
Shell Duration	10.50 msec
Average Duration	12.26 msec
PEAK POSITIVE PHASE IMPULSE	
Top Impulse	44 psi*msec
Right Impulse	43 psi*msec
Shell Impulse	42 5si*msec
Average Impulse	43 psi*msec
GLAZING RESPONSE	
Exterior Lite	Unbroken
Interior Lite	Unbroken
Glazing Pullout	None
Film Tearing	None
WITNESS CHAMBER RESULTS	
No debris was observed.

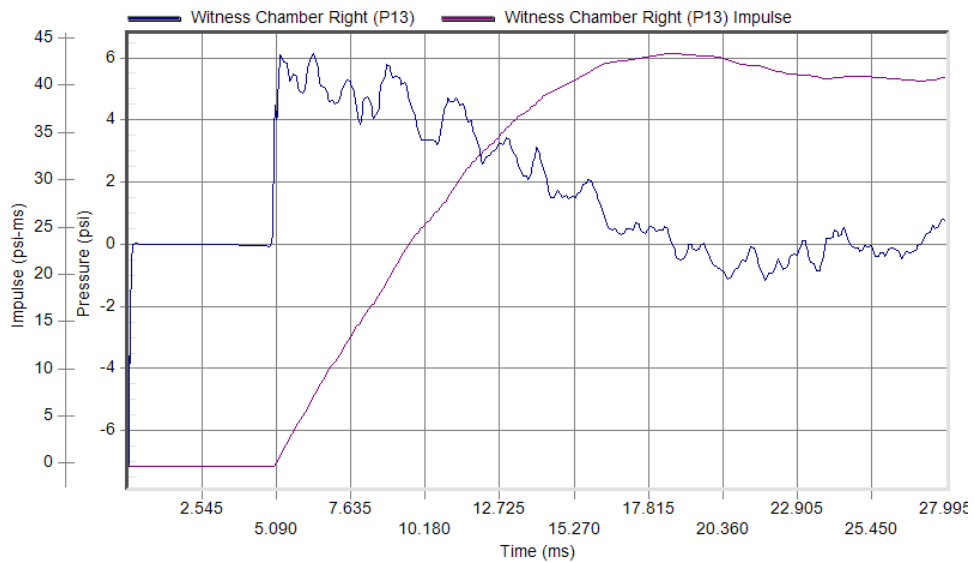
Peak Pressure: 6.15 psi at 5.26 ms
Duration: 13.35 ms

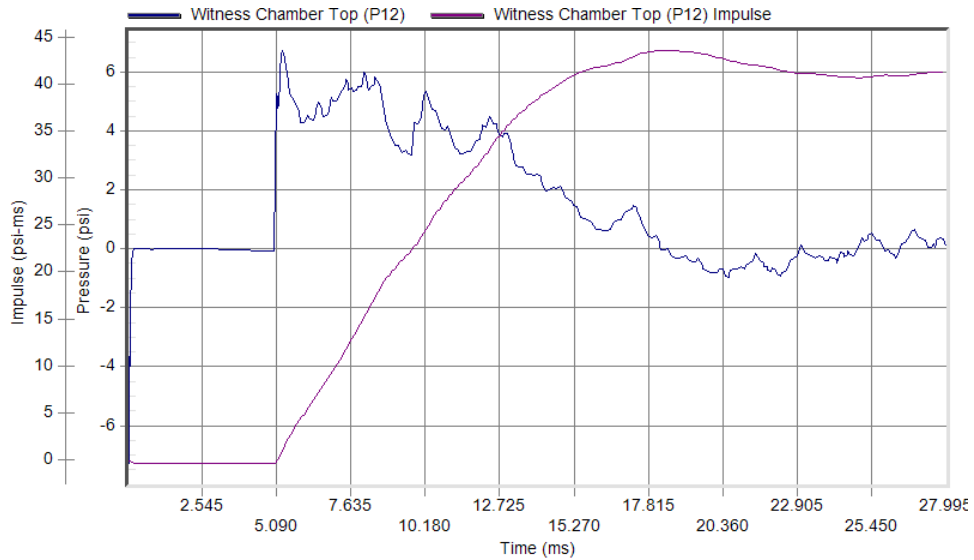
Peak Pressure: 6.74 psi at 5.31 ms
Duration: 12.91 ms

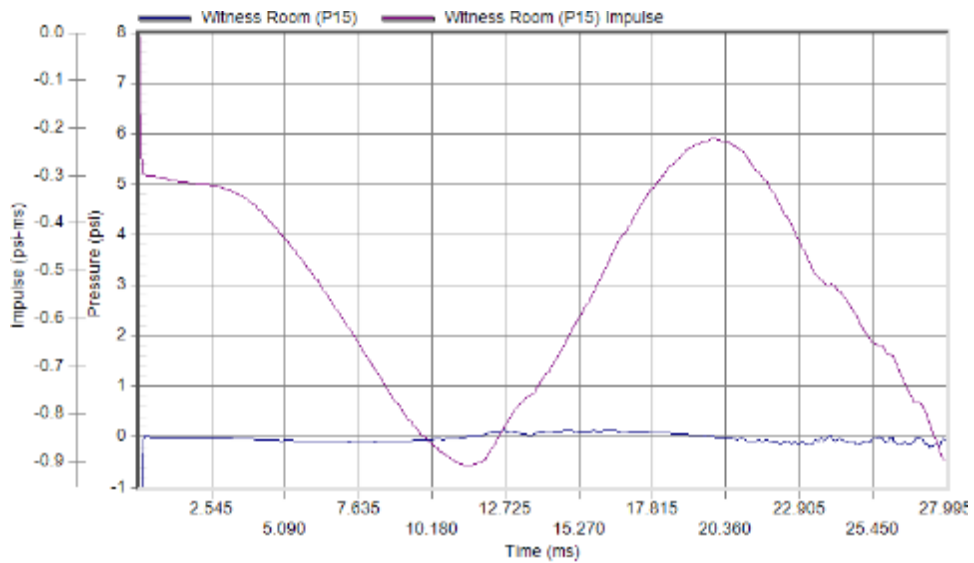
Peak Pressure: 0.13 psi at 16.29 ms
Duration: 3.63 ms

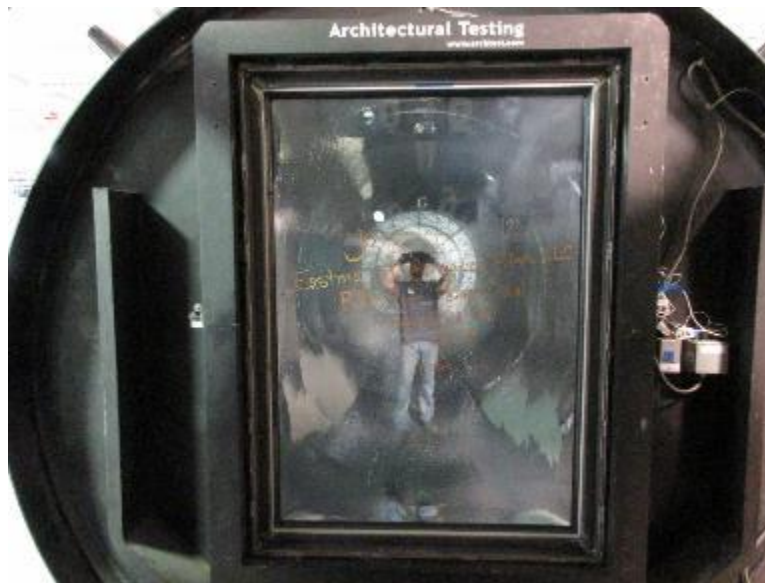
Photo No. 2
Post-test Specimen #1, Interior

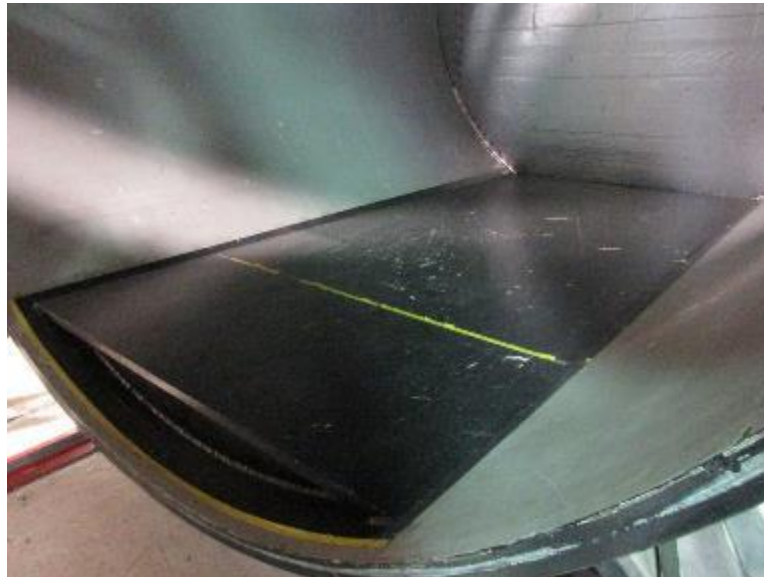
Photo No. 3
Post-test Specimen #1, Witness Chamber

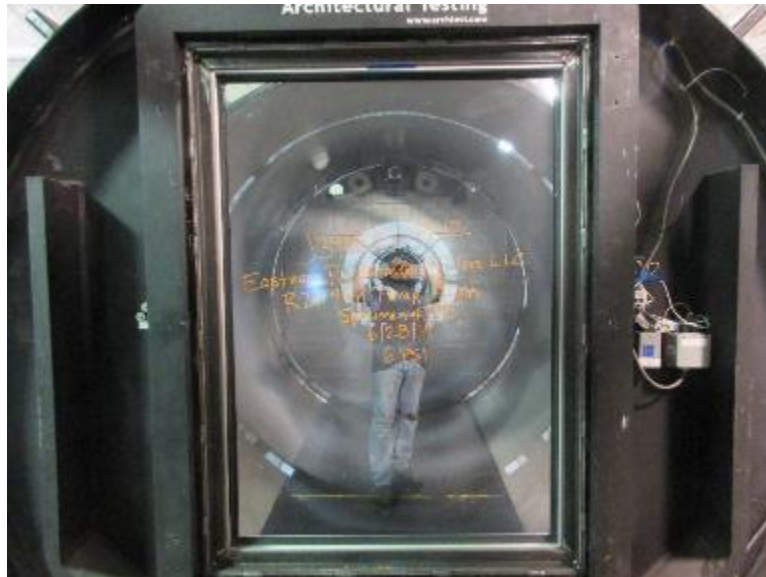
Photo No. 5
Post-test Specimen #2, Interior

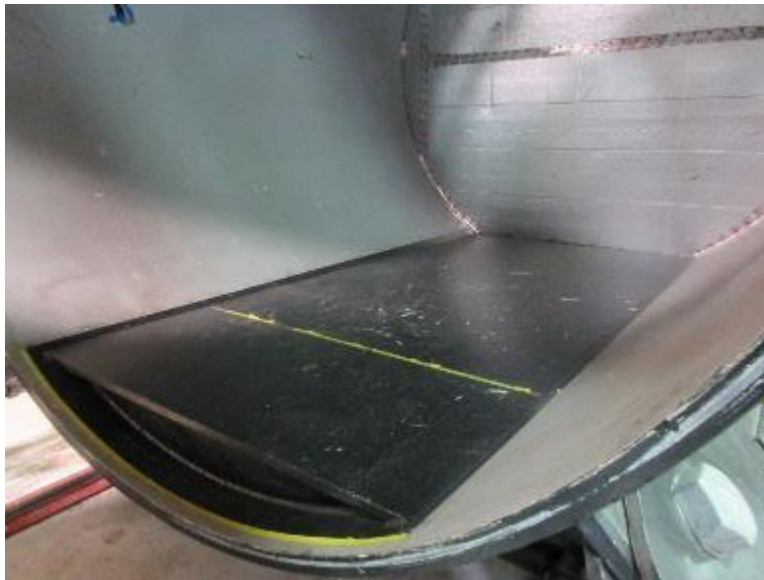
Photo No. 6
Post-test Specimen #2, Witness Chamber

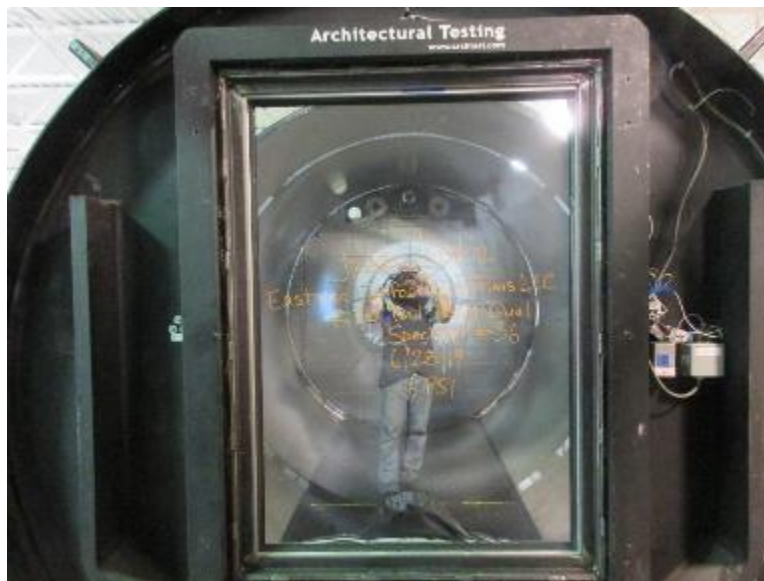
Photo No. 8
Post-test Specimen #3, Interior

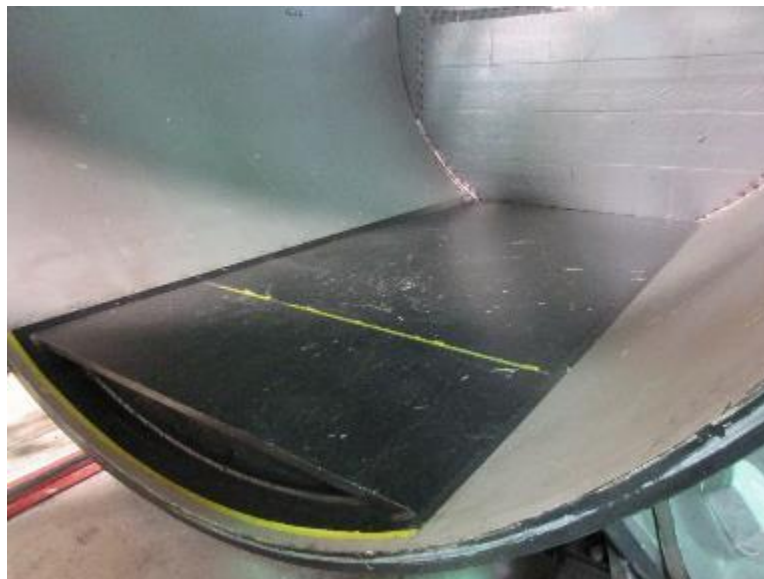
Photo No. 9
Post-test Specimen #3, Witness Chamber

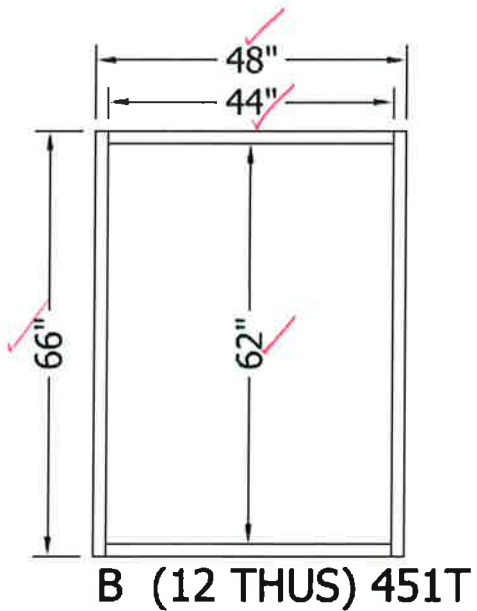
Dual-pane unit frames

Kawneer 451 Aluminum Framing
